Tanker separates on I-35W at I-694

by Trevor Hamdorf, Deputy Fire Chief - New Brighton Department of Public Safety

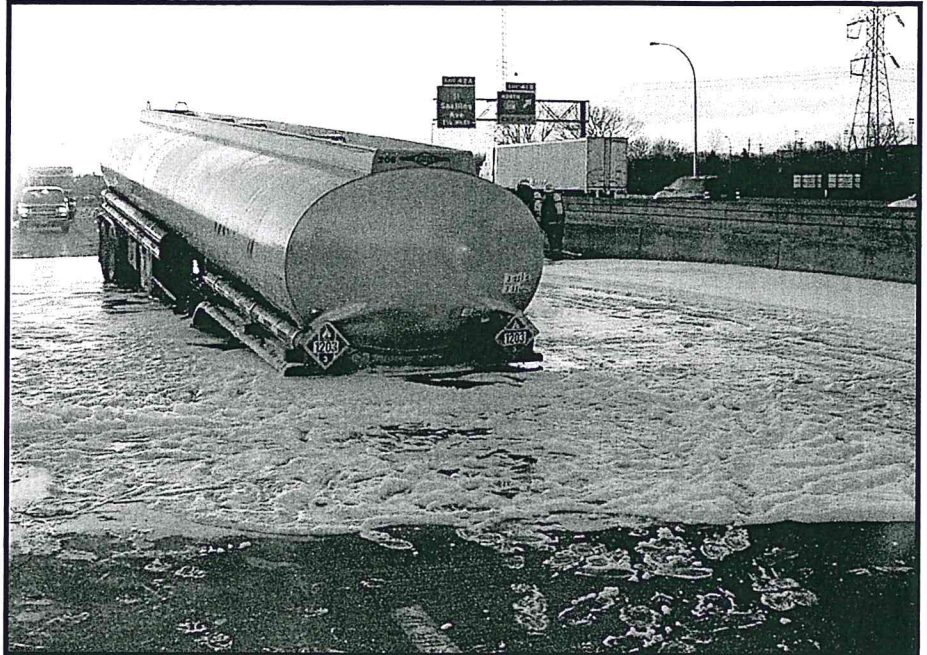
The initial arriving New Brighton Chief established I-694 Command and conducted a size up. The Incident Commander observed a MC406 trailer placarded with UN1203 (Gasoline) separated from the tractor with a working gasoline fed fire under the belly of the trailer in the area of the landing gear. Several years prior, the New Brighton Fire Division partnered with a local fuel transporter and had train-

ing on elements of a MC406 trailer. Additionally, there was a responder education campaign about "wet lines" on MC406 trailers and the resulting fuel spills associated with damage to them. The "wet lines" are essentially the pipes under the tanker trailer which move the product from the containment vessel to its final destination and remain filled with product. There are clapper valves contained within the container that are designed to close when the "wet lines" are damaged preventing additional fuel loss. Based upon this information, there were two potential causes of the fuel fed gasoline fire, either the landing gear breached the container when the trailer slammed down on the highway or the fuel was a result of the "wet lines" losing their product. Based upon the size-up we were unable to determine what the cause of the fuel leak supplying the fire was.

Many elements of the incident worked in our favor that day. We were fortunate the fire was a result of the wet lines releasing their product and not a compromised tank due to landing gear damage. Despite damage to the tank, it did not rupture when it fell off the tractor. The fire was under the tank, impinging on the liquid which absorbed the heat and mitigating serious heat damage to the containment vessel. The physical controls built into the MC406 tank and the actions of the first arriving engine crew substantially contributed to the successful resolution of this incident and avoided the CNN morning headline, "BURNING TANKER ON BRIDGE IN MINNESOTA." ❁
